SAFETY ALERT

FATALITY -

FAILURE OF AIR-HOSE CONNECTION

QUALITY - ENVIRONMENT - SAFETY - HEALTH BULLETIN NO. 06 / 2003

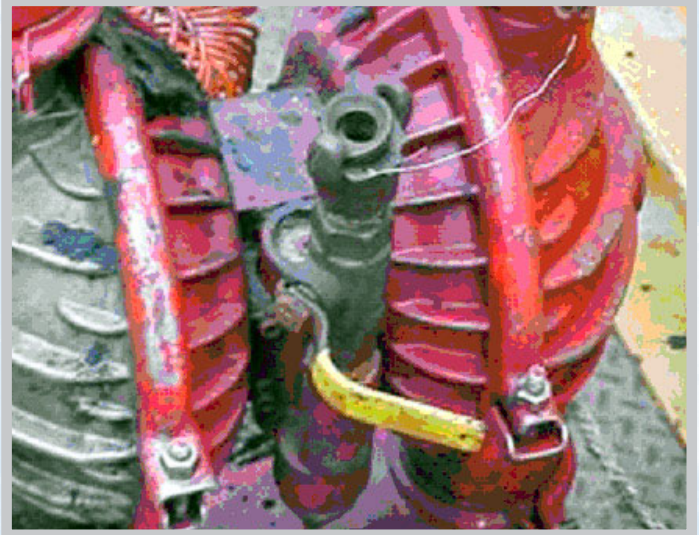
A worker was struck on the head by a compressed air hose which blew off its fitting on a piece of equipment. He received serious head injuries which proved fatal.

The air hose was held by a hose clamp on the fitting with no keeper or restraining chain or sling to prevent the hose from thrashing around.

The primary cause of this accident was the failure to secure the hose and hose clamp by means of keeper or sling and chain respectively.

Restraining devices such as keepers, chains, slings, proprietary special couplings and whip-checks should be installed on all diameter or high pressure compressed air hoses to prevent them thrashing about in the event of a hose or coupling failure.

Regular inspections of all compressed air powered equipment, including hoses, should be carried out to assess the integrity of the couplings, clamps, keepers and hoses and corrective action taken where necessary.
